REPORT NO. NADC 88109-60

**THE EFFECTS OF PLASTIC MEDIA BLASTING
PAINT REMOVAL ON THE MICROSTRUCTURE
OF GRAPHITE/EPOXY COMPOSITE MATERIALS**

Joseph Kozol, Steven Thoman and Kenneth Clark
Aircraft and Crew Systems Technology Directorate
NAVAL AIR DEVELOPMENT CENTER
Warminster, PA 18974

Final Report
October 7, 1988

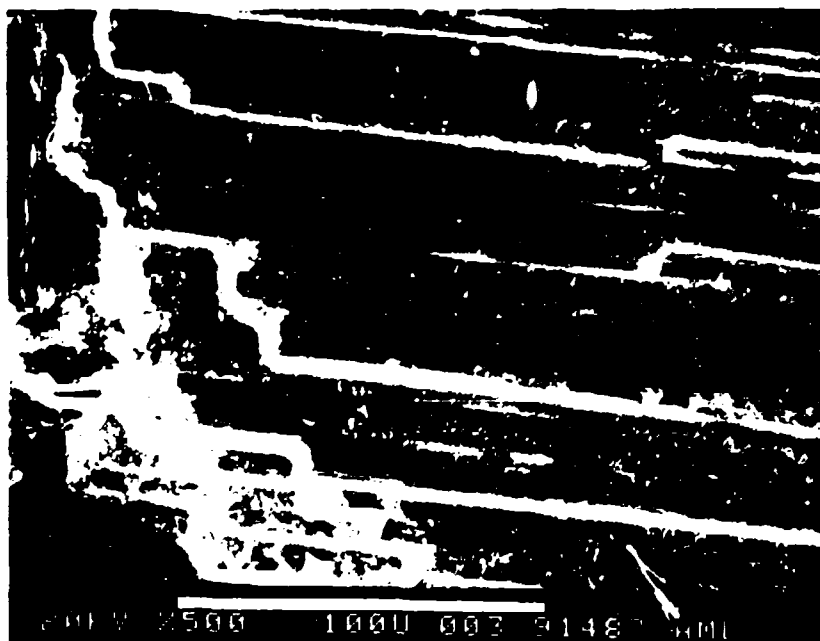
Under more severe PMB conditions, increased resin abrasion and a small amount of localized fiber damage occurs. This type of damage is typical of category 2 and is shown in figure 6. The release ply pattern is still visible in figure 6(a) and some scattered areas of fiber fracture can also be seen. A higher magnification photomicrograph of one of these fiber fracture areas is

shown in figure 6(b); however, most of the surface does not contain fiber damage.

Figure 6. Category 2: Minor Fiber Damage (Type II Media, 45° Angle, 12" Distance, 35 psi, 30-40 Sieve Size)

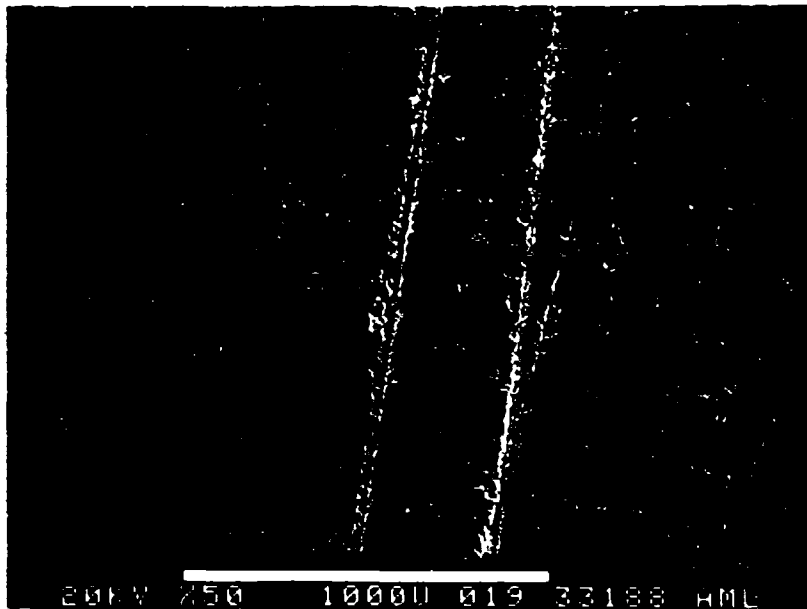
Examination of the panels after sanding revealed that paint removal was non-uniform. The samples had areas of complete coating removal and other areas with the primer remaining. SEM photomicrographs of the surface are

shown in figure 11. The lower photomicrograph, taken at 500x, shows that considerable fiber damage has occurred. The surface damage rating for this paint removal method falls into category 3 since the release ply pattern is no longer visible and extensive fiber damage is evident.

Figure 11. Surface of GR/Ep After Coating Removal by Sanding (180 Grit)
